Sanitary Wastewater Management: Cabo San Lucas Country Club Biological Remediation - Sewper Rx application Bacteria/Enzyme Treatment into Primary Waste Water Lagoon No.1

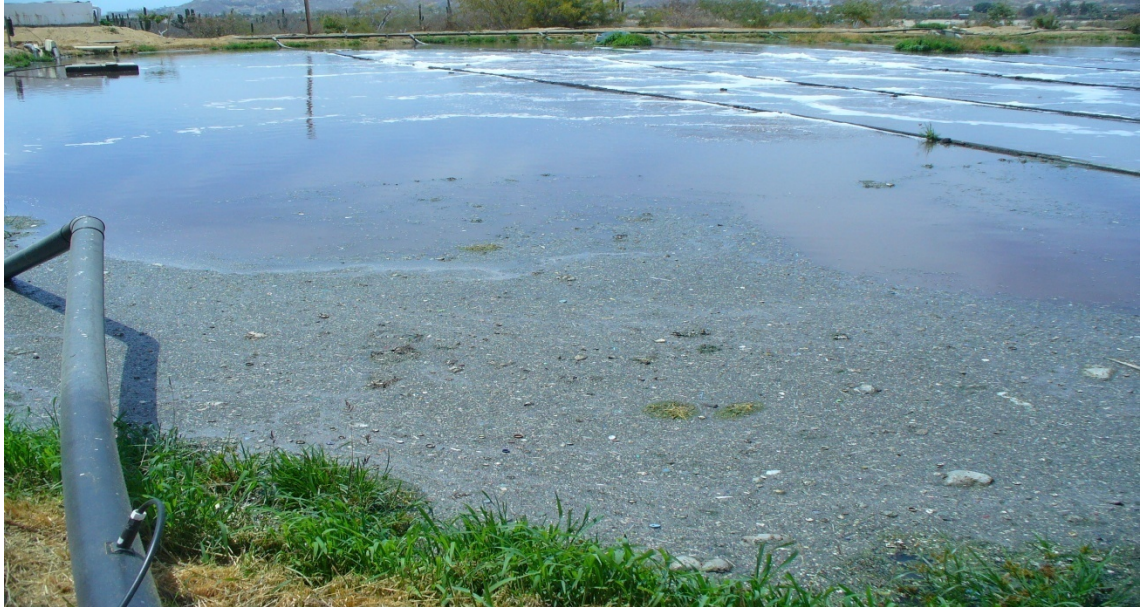
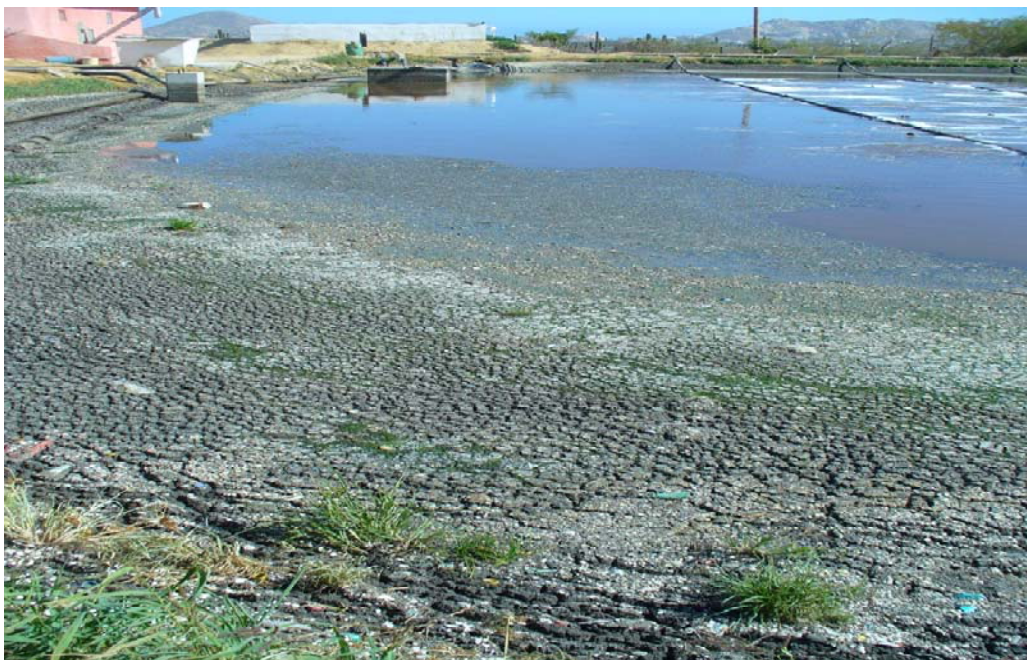
Primary Lagoon 1 has been receiving raw water almost 20 years;
Image above illustrates sludge blanket at normal water levels;
Image below illustrates sludge blanket at low water level 4/10/08

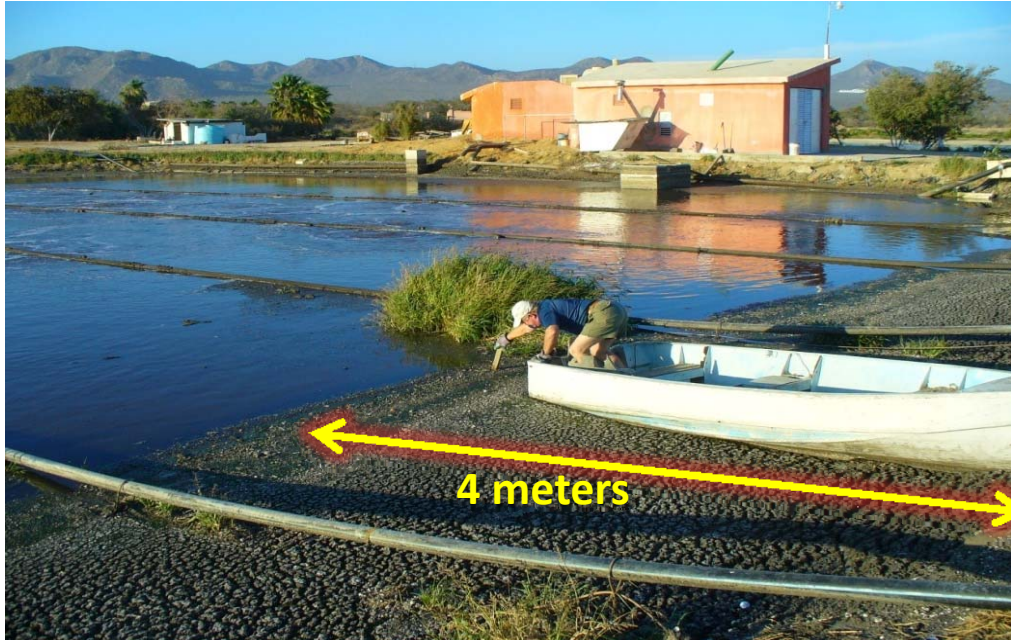
On 5/01/08 a 250 cm sludge level marker/indicator stake was installed at the sludge-water interface of Primary Lagoon 1, approx 4 meters from the edge and about 40 meters from the discharge structure:

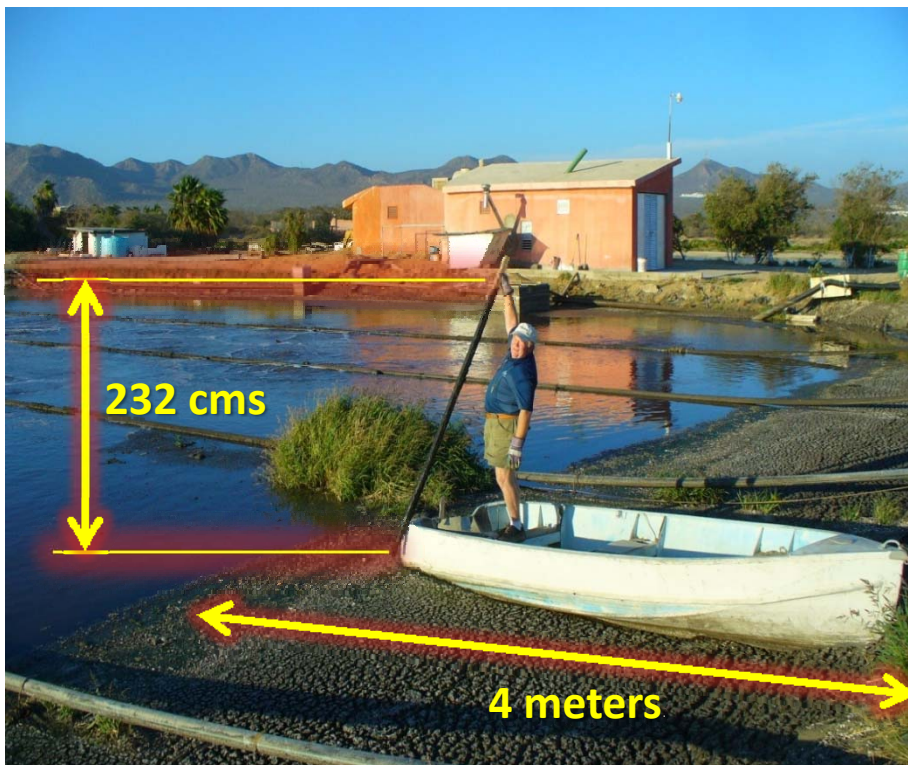
On that date and at that location, sludge depth was measured and determined to be **232 cms**;

The original marker/indicator stake measured 248 cms total length (TLM); once installed and secured in place in the sludge blanket, the extended length of the marker stake over the top of the sludge was measured on 5/01/08 to be 18 cms, indicating sludge depth at the marker position to be 232 cms;

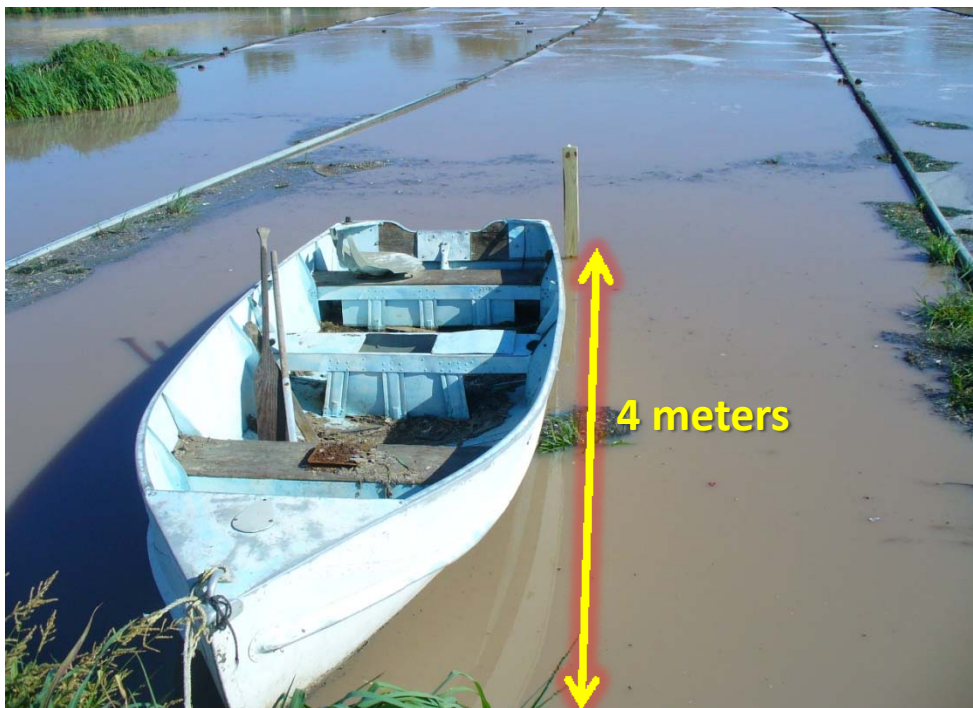
Due to extreme hydraulic loading, Lagoon 1 water levels were too high to read conveniently monitor the original sludge marker/indicator, so on 8/10/08 a new 305 cm long (10 ft) marker was installed at the same location as the original 248 cm marker/indicator post; the exposed height of the new marker post was measured at 75cms (over water level) .

The new marker/indicator stake measures 305 cms total length (TLM); the exposed height of the new marker, over water level measured 75cms;

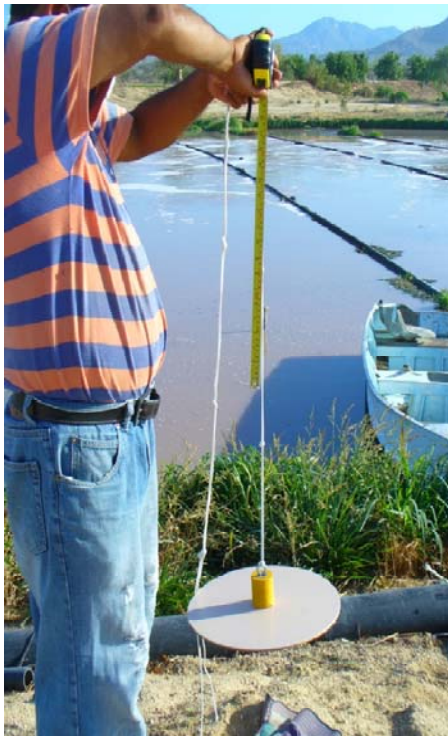
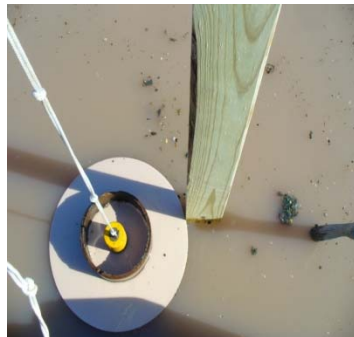
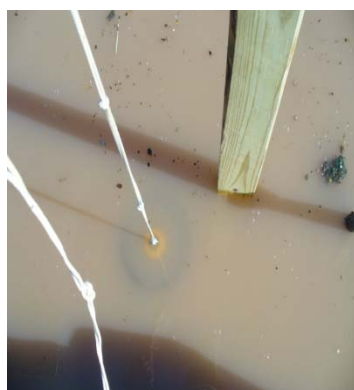
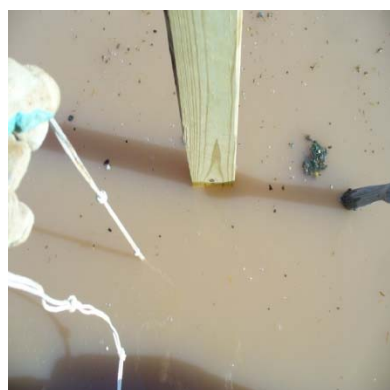
A 30 cm diameter “cork disc plate” was assembled with 30 cm depth indicators; the plate measures the depth (height) of water over the top of the sludge blanket by

lowering the cork disc plate is into the water at the marker/indicator position, until it rests securely on the top layer of the sludge blanket; then water depth is measured and recorded:

On 8/11/08 at the new marker/indicator location, water depth over the sludge was measured with the “cork-disc” method and recorded to be 55 cms;

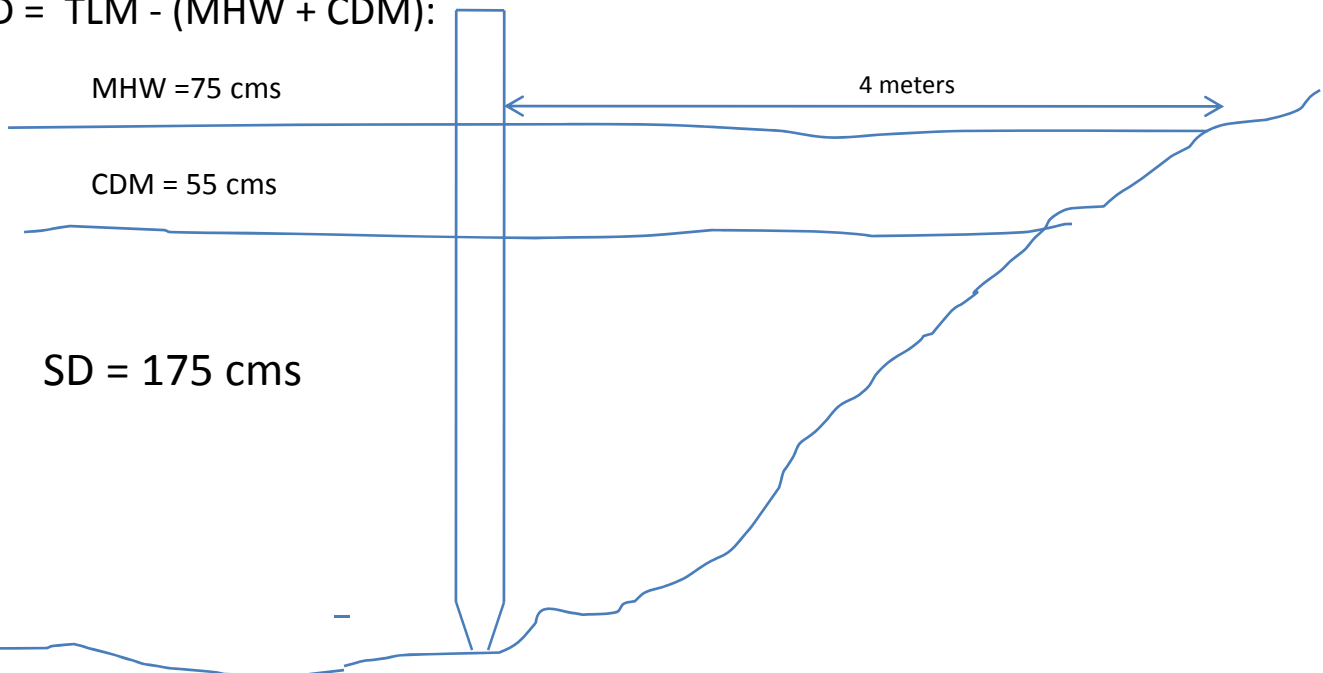
Sludge Depth (SD) may be calculated by adding the maker height (MHW) exposed over the water, plus the water depth measured by the “cork-disc” method (CDM), the sum is subtracted from the total length of marker (TLM);
 $SD = TLM - (MHW + CDM):$

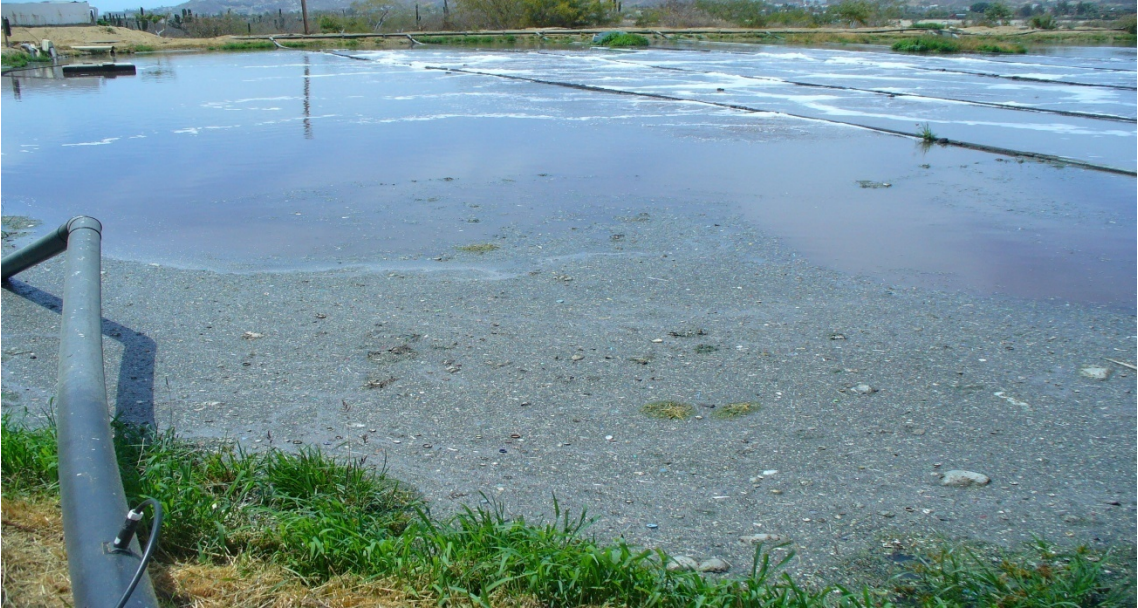
To estimate the net change of sludge volume (ΔSV) in Primary Lagoon 1 that has occurred from 05/01/08 to 8/11/08, subtract the original 230 cm SD calculation from the most recent 170 cm SD calculation, and multiply by the average surface area of 5000 m²:

$$\Delta SV = (170-230) / 100 \times 5000 = -(.60) \times (5000) = 3000 \text{ m}^3$$

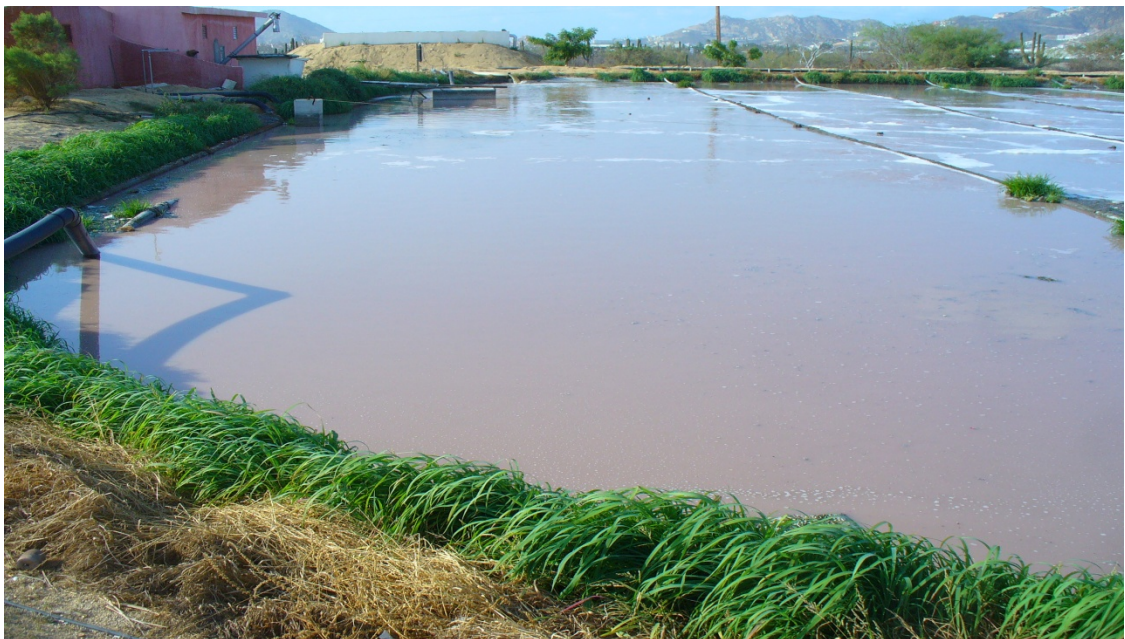
In addition, a ΔSV qualitative analysis of may be observed from visual comparison of the perimeter sludge blanket, before and after;
