Sanitary Wastewater Management: Cabo San Lucas Country Club Biological Remediation - Sewper Rx application Bacteria/Enzyme Treatment into Primary Waste Water Lagoon No.1

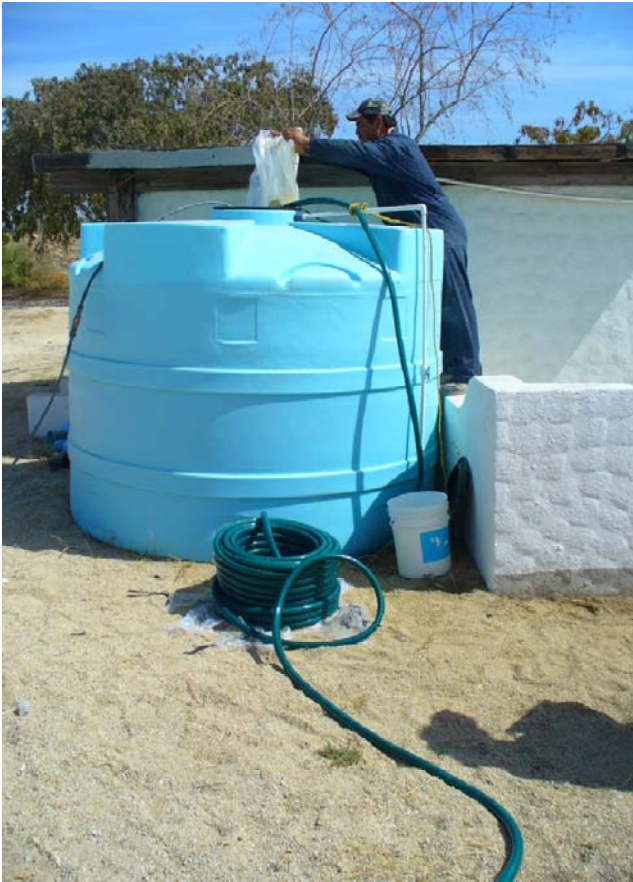
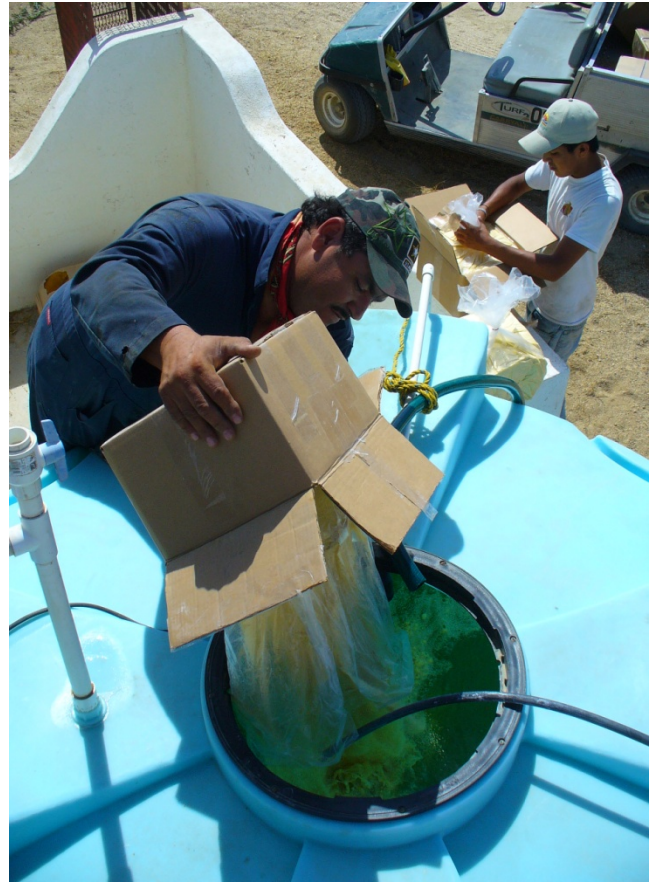
CIASA technicians arrived CSLCC BCS Lagoon WWTP site: 4/29/2008;
Procured materials and provisions to apply bacteria-enzyme product 4/30/08–5/01/08;
450 lbs/204.2kgs Sewper Rx bacteria-enzyme product delivered to site Friday 5/02;
Initiated product mixing & inoculation of first 5m³ container, Saturday 5/03/08;

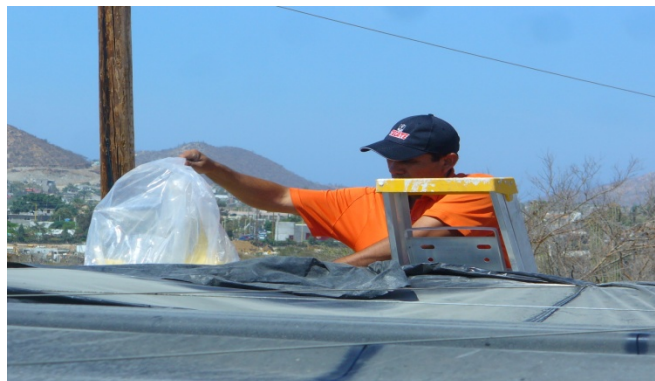
NOTE: due to hydraulic demand for irrigation water, lagoon levels were 25% below normal, proportionally reducing lagoon volume. Therefore, the recommended **SewperRx** application rate of 1 kilogram per 10,000 gallons of lagoon volume was recalculated for the initial Ph 1 application process, creating additional material available for inoculating Lag No. 2 with an initial treatment application; 30 kgs **SewperRx** was mixed into 100 m³ Flow Stabilization Tank for bacterial inoculation process in Lagoon No. 2;

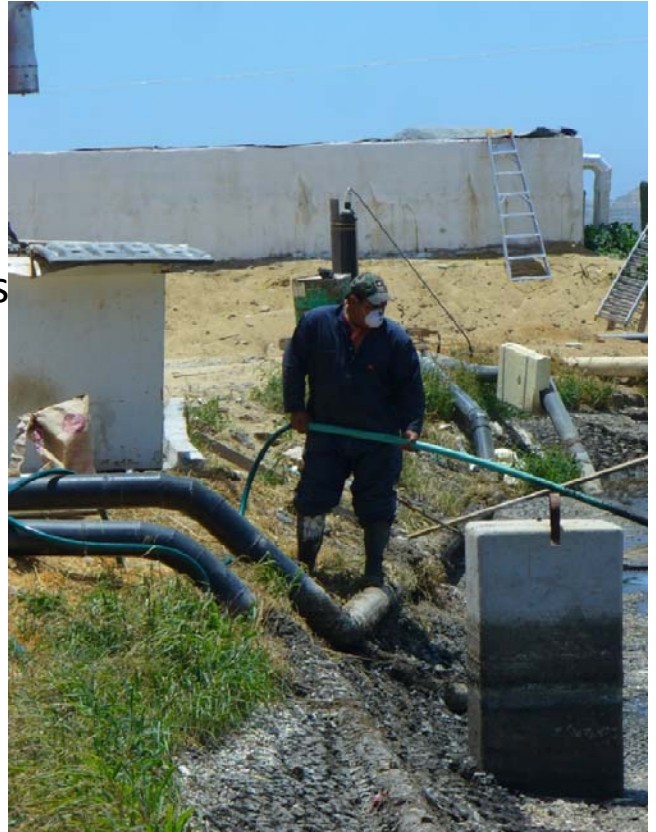
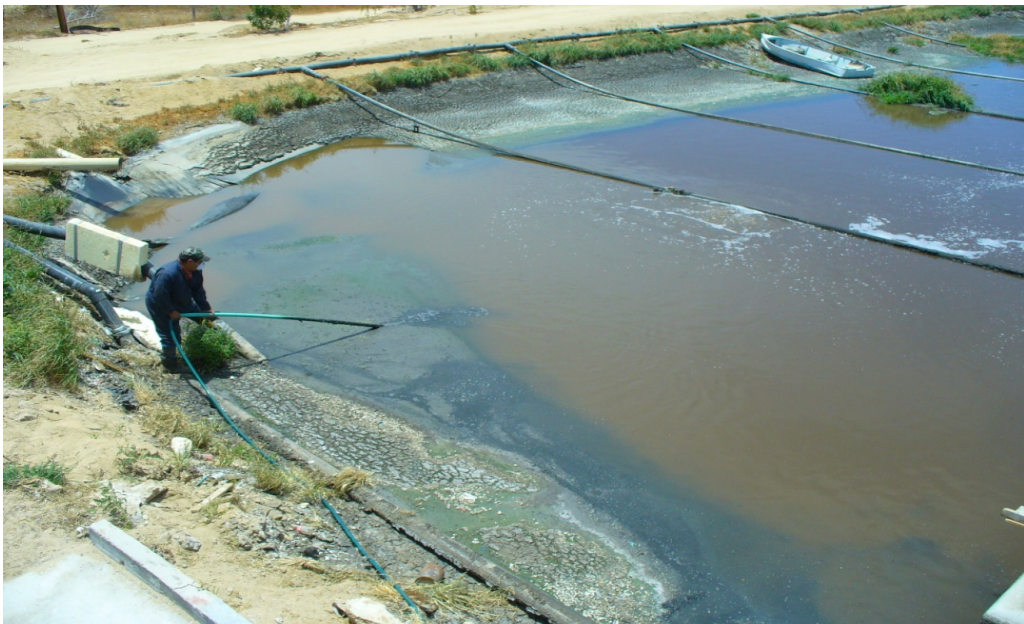
SewperRx Lagoon 1 sludge treatment program began 5/04/ 2008;
Proceeded with Lagoon 1 bacterial solution application 5/5-10/08;
Completed -terminated injection treatment program 5/12/2008;

170 kgs dry product pre mixed
and pressure injected as a liquid
slurry into the sludge blanket
surrounding Lagoon 1 perimeter
on alternating - consecutive day s

May 04: 50 kgs

May 07: 40 kgs

May 09: 40 kgs

May 11: 40 kgs

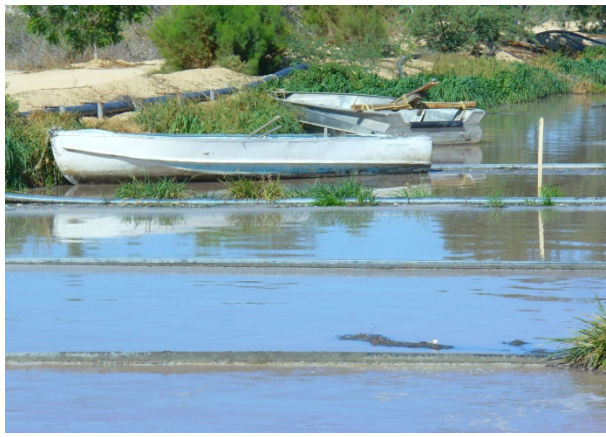
The original marker/indicator stake measured 248 cms total length (TLM); once installed and secured in place in the sludge blanket, the extended length of the marker stake over the top of the sludge was measured on 5/01/08 to be 18 cms, indicating sludge depth at the marker position to be 232 cms;

The new marker/indicator stake measures 305 cms total length (TLM); the exposed height of the new marker, over water level measured 75cms;

On 8/11/08 at the new marker/indicator location, water depth over the sludge was measured with the “cork-disc” method and recorded to be 55 cms;
